Manhole Inspection Summary

Manhole # S45AA_023MH

Insp Date: **3/9/10 11:46 AM**

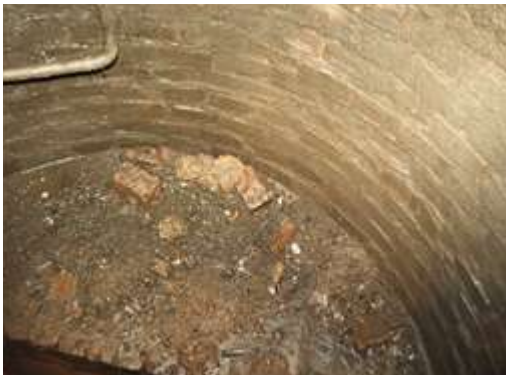
Defect 1

debris

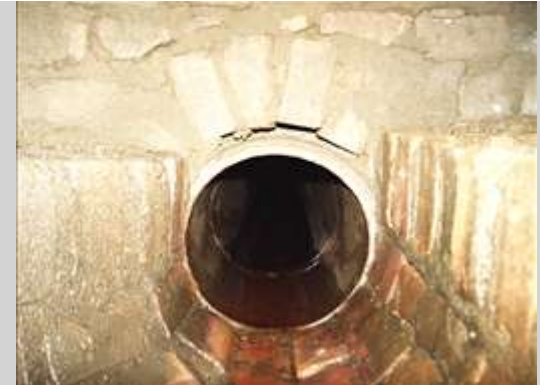
12 O'Clock Outflow

Pipe Height: **12** (in.) Rod and Bar (Angled)
Pipe Material: **Clay** ☐ Pipe Lined
Invert Depth: **11.67** (ft.) Flow Characteristics: **Slow**
Deposits: ☒ None ☐ Mud ☐ Sludge ☐ Debris ☐ Grease
Silt Depth: (in.) Deposits Extent:
Infiltration: **None** Pipe Seal Cond: **Sound**

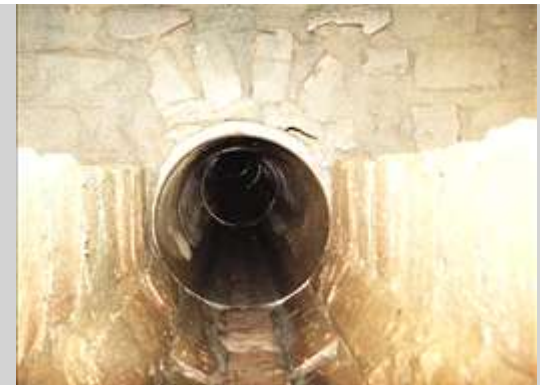
6 O'Clock Inflow

Pipe Height: **12** (in.) Rod and Bar (Angled)
Pipe Material: **Clay** ☐ Pipe Lined
Invert Depth: **11.33** (ft.) Flow Characteristics: **Slow**
Deposits: ☒ None ☐ Mud ☐ Sludge ☐ Debris ☐ Grease
Silt Depth: (in.) Deposits Extent:
Infiltration: **None** Pipe Seal Cond: **Sound**

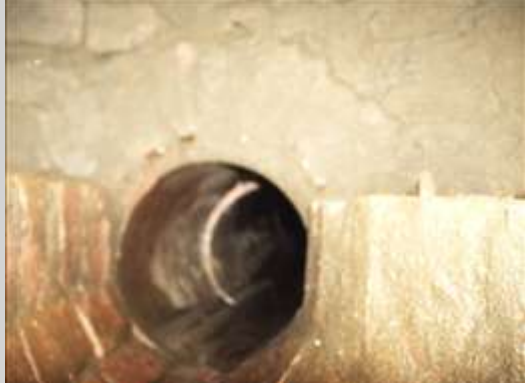
9 O'Clock Inflow

Pipe Height: **12** (in.) Rod and Bar (Angled)

Pipe Material: **Clay** ☐ Pipe Lined

Invert Depth: **11.33** (ft.) Flow Characteristics: **Slow**

Deposits: ☒ None ☐ Mud ☐ Sludge ☐ Debris ☐ Grease

Infiltration: **None** Pipe Seal Cond: **Sound**
